Today I replaced my torn CV boot at home. Isuzu will tell you the CV's are NOT a serviceable part and that the entire shaft needs to be replaced at a cost of \$850 per side. Since I had everything apart I changed both the inner and outer boot. Parts cost me \$33 for both the inner and outer boot (x2 if doing both sides) and another \$2.99 for a can of brake cleaner. \$36 vs. \$850! All you need is a willingness to get dirty and greasy and about 2 hours of your time. Here is the culprit...The torn boot

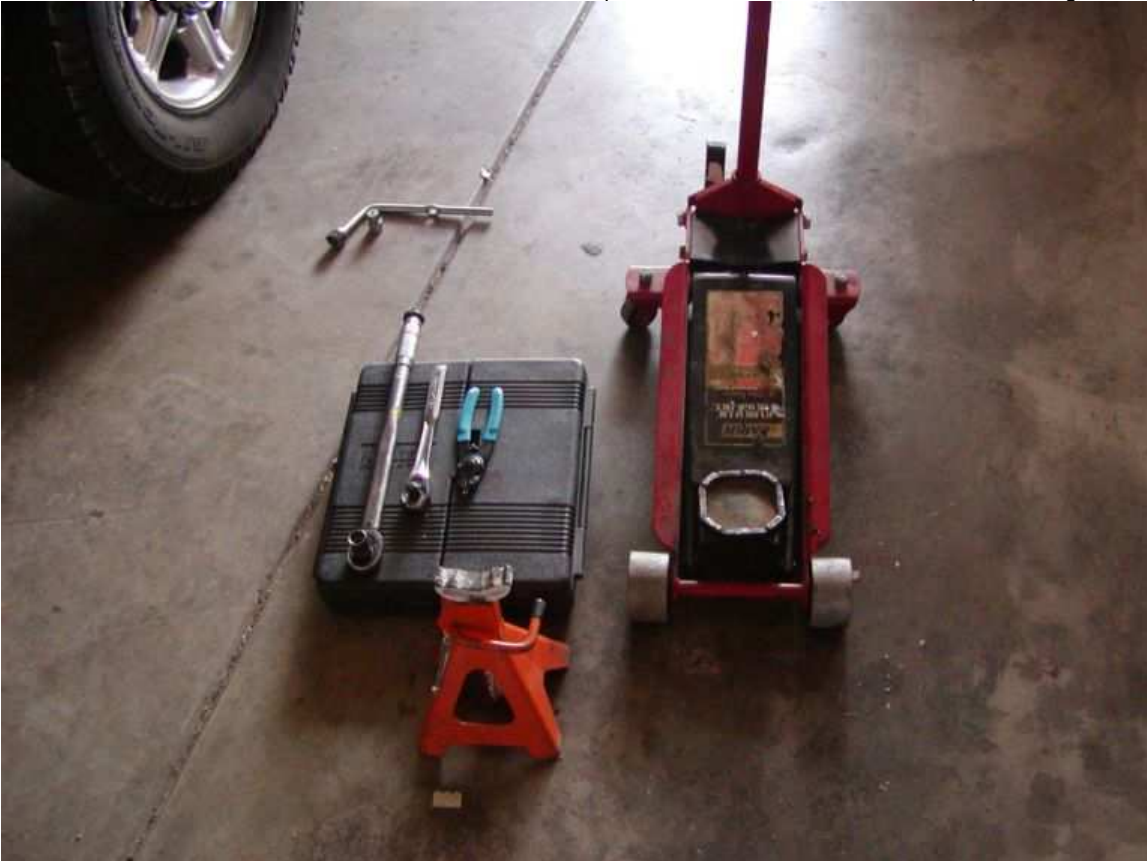
Very few tools are needed to do the job: 1 jack, jack stands, a deep 17mm socket, ratchet (a long one helps for leverage needed), snap ring pliers, a screw driver, rags and a can of brake cleaner. A band tool is helpful also...I didn't use one and it was a pain but I got it done.

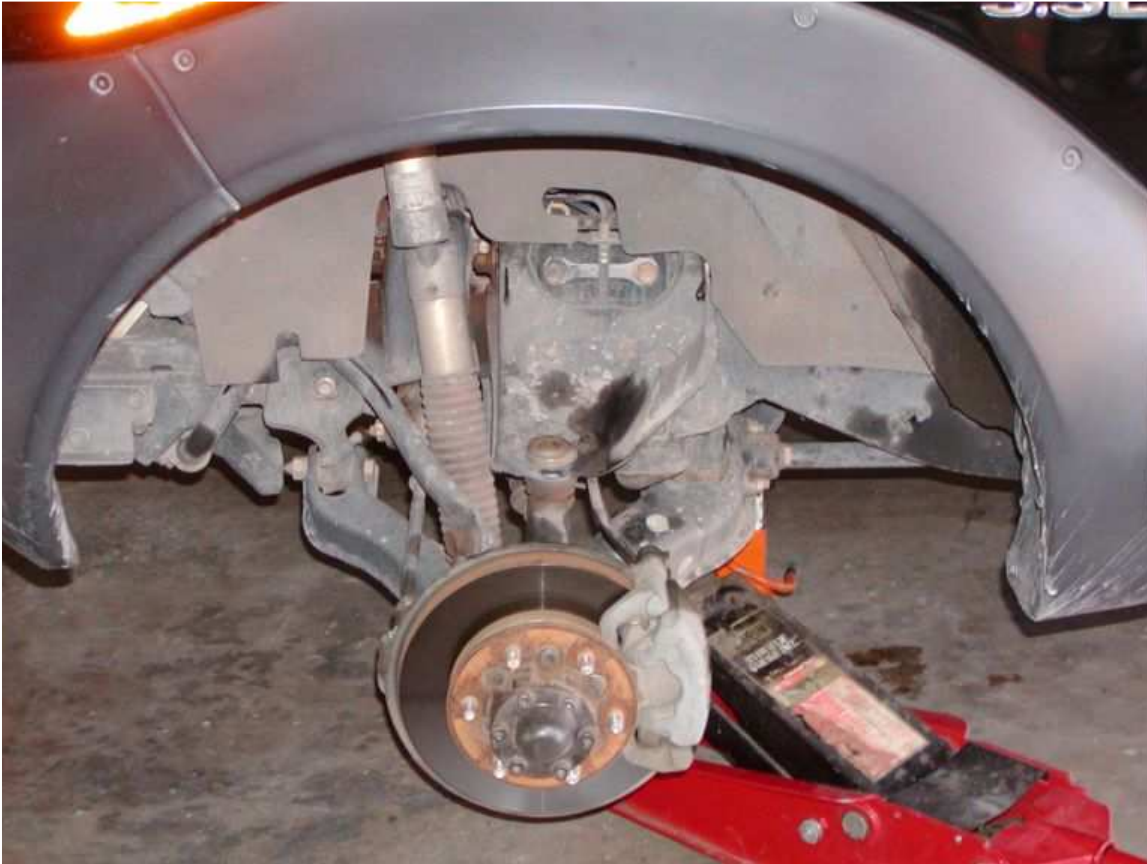
Jack up the front of the VX and place it on jack stands.
Remove wheel/tire.

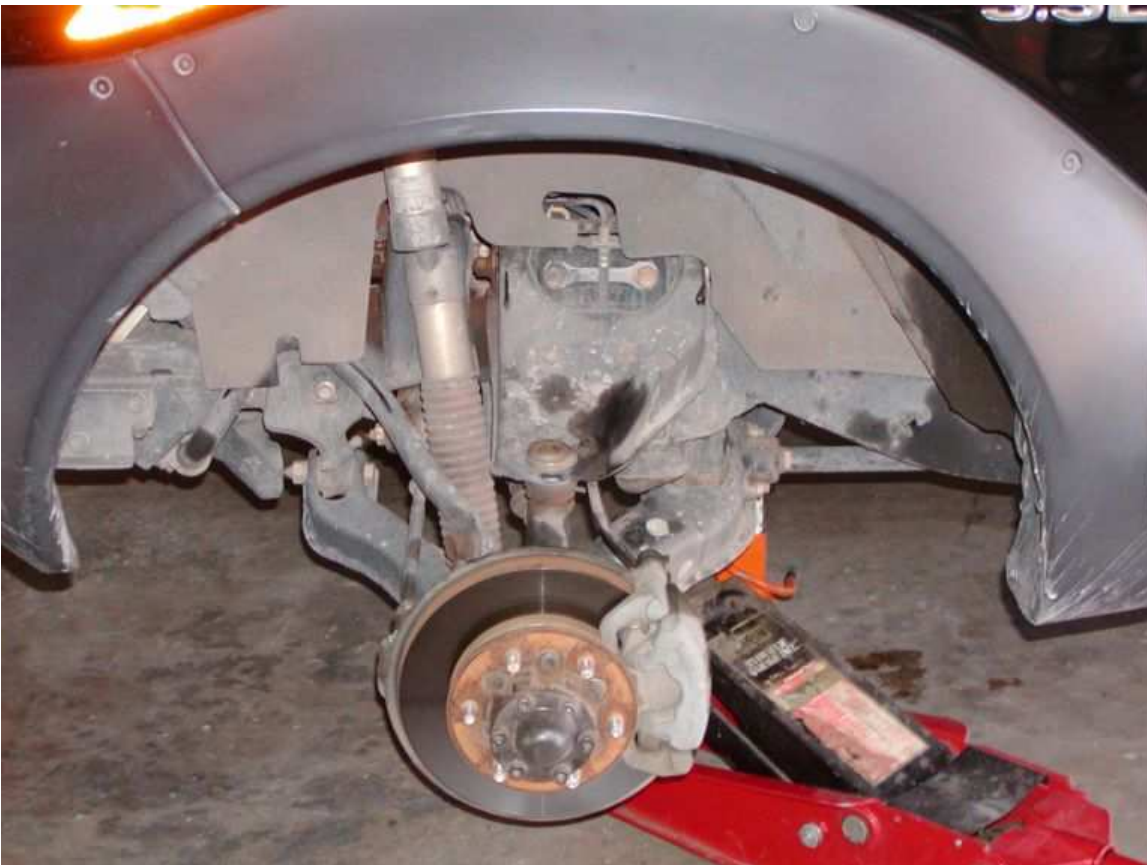
Place jack under lower control arm and lift to relieve pressure on the lower ball joint.

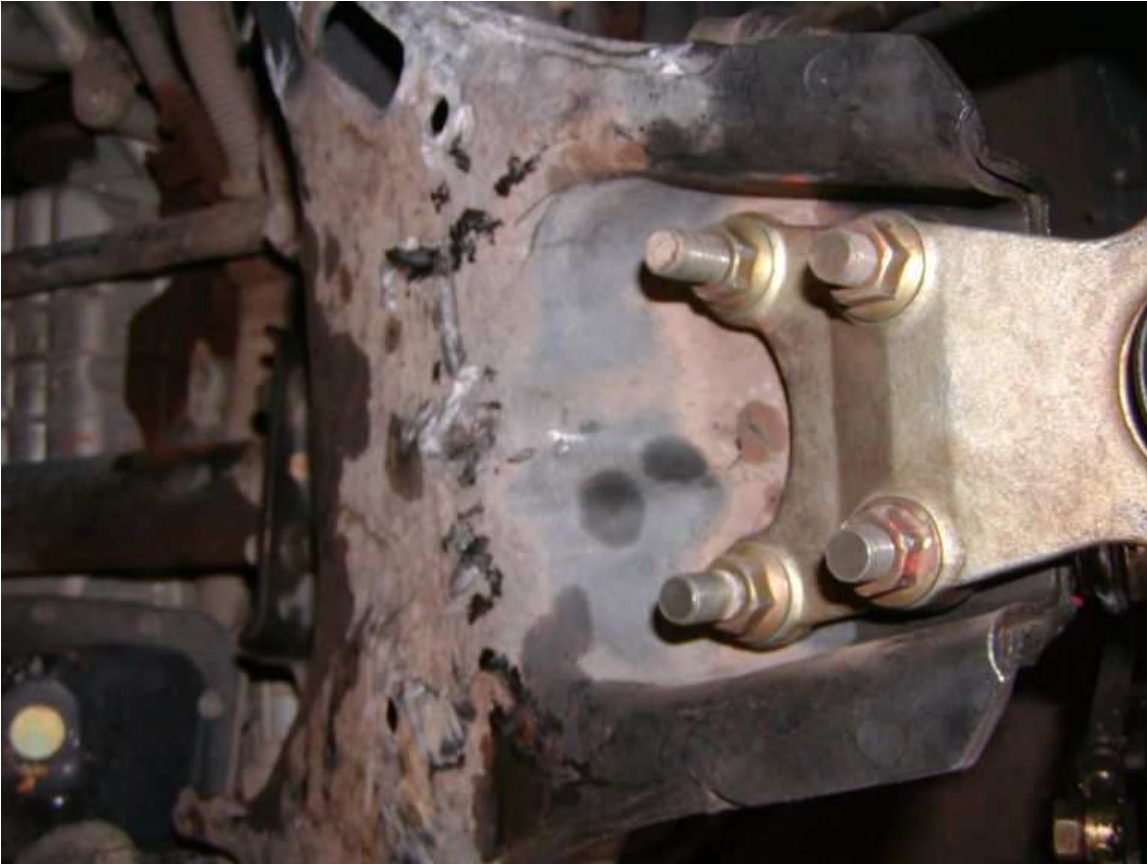
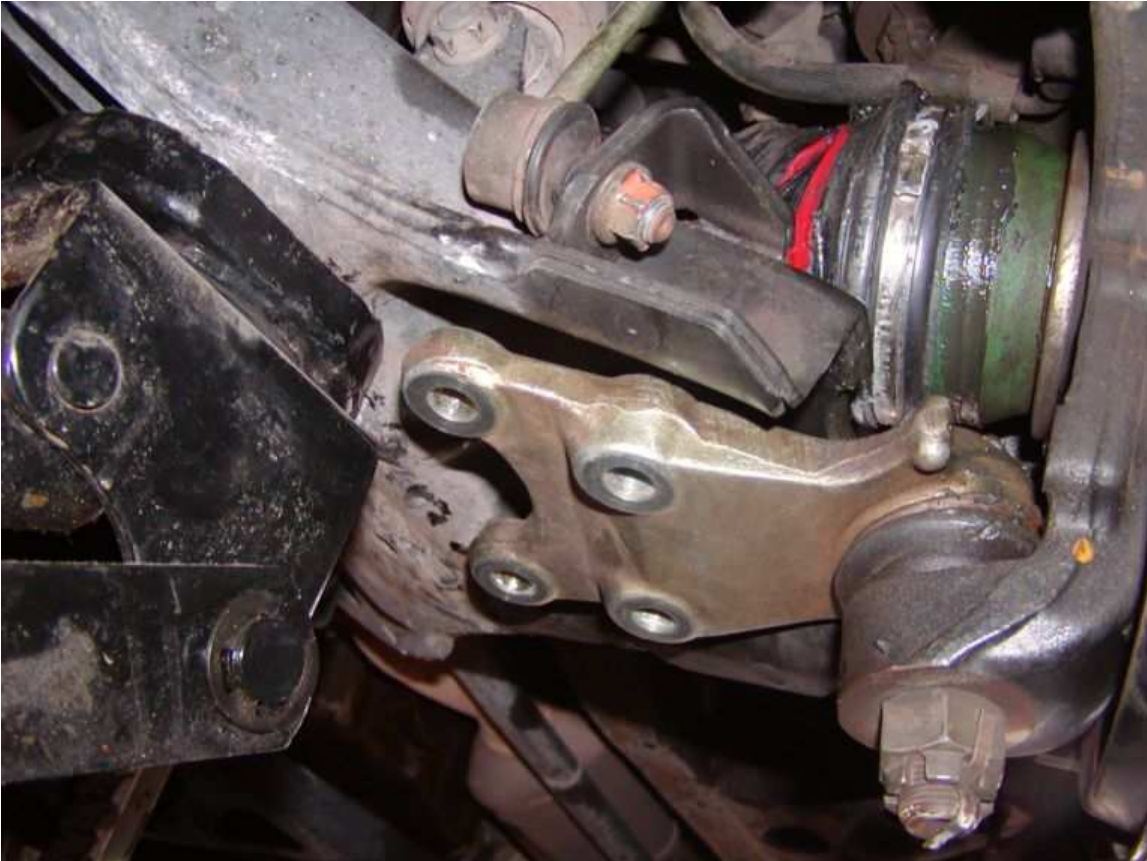
Remove the 4 17mm bolts on the bottom of the lower control arm that hold the ball joint bracket.

(yes, that is duct tape as a VERY temporary fix till I got a chance to do the boot change)
Next reposition the ball joint bracket to the top of the lower control arm.

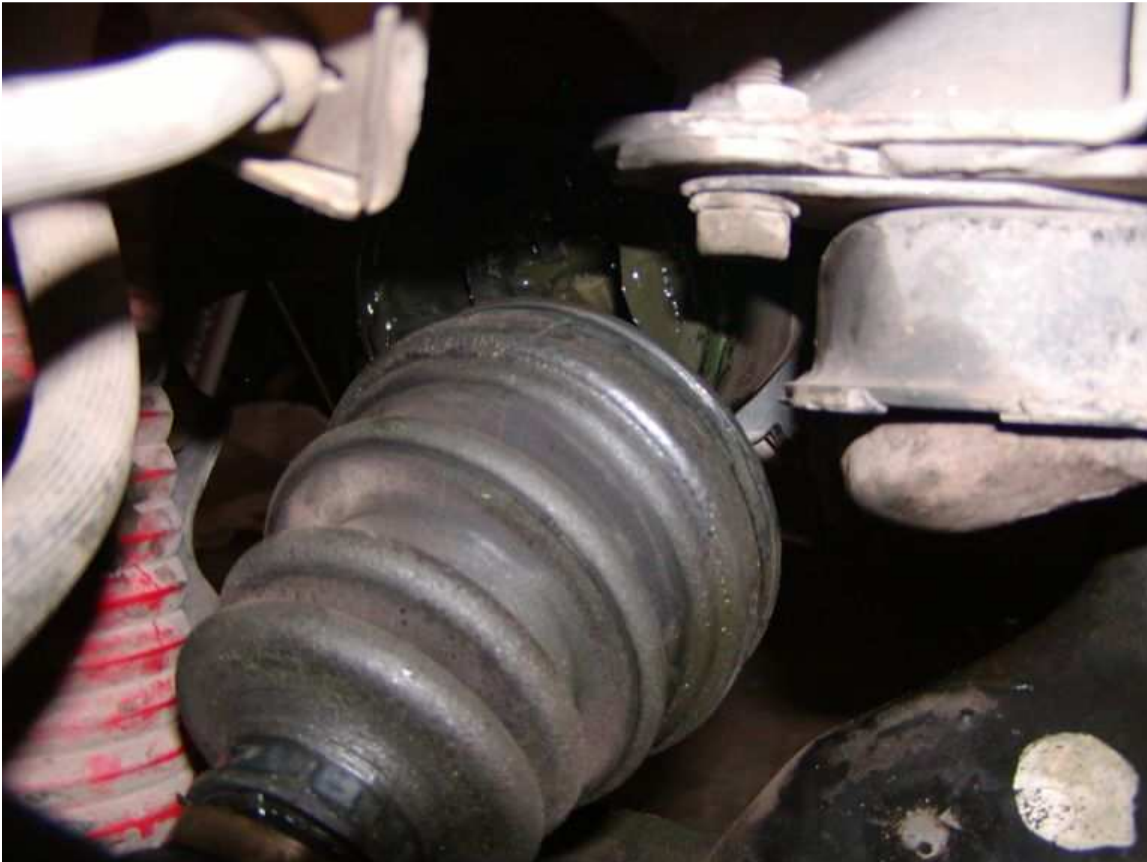
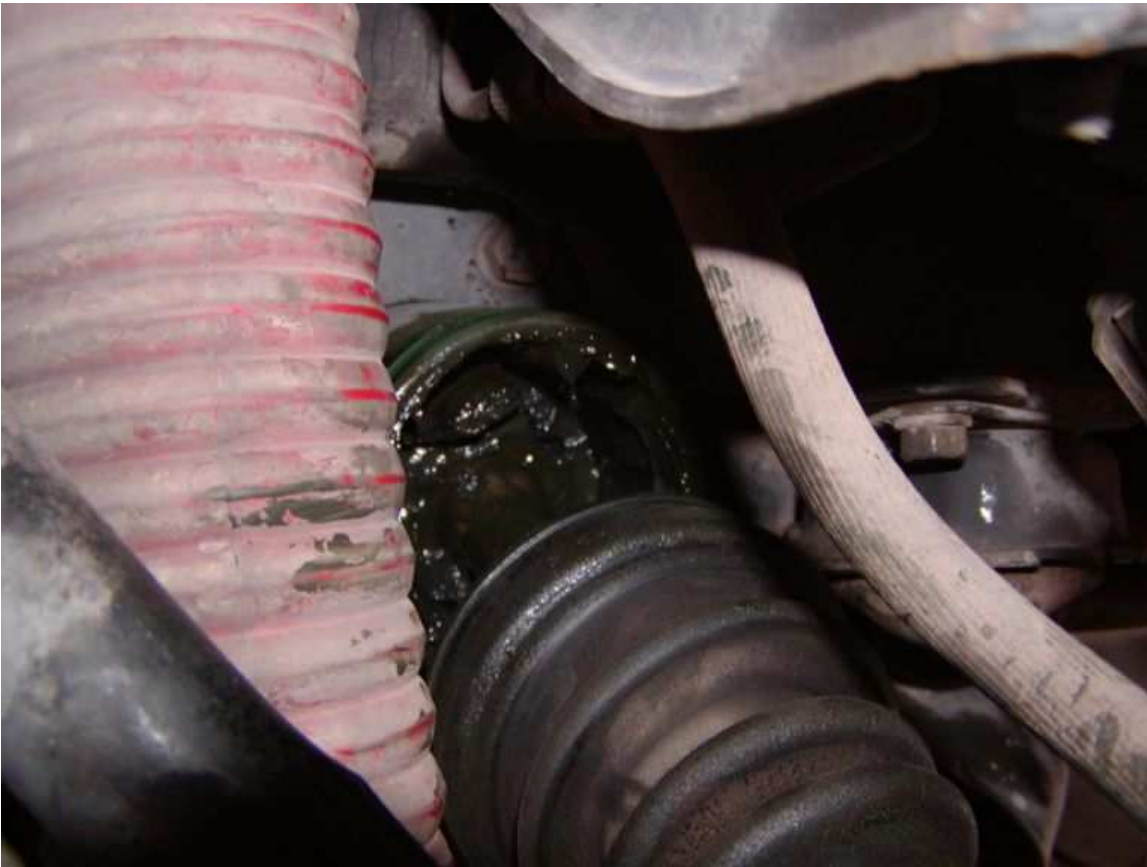
Remove the bands from the INNER CV BOOT.
Move boot off of CV Joint.

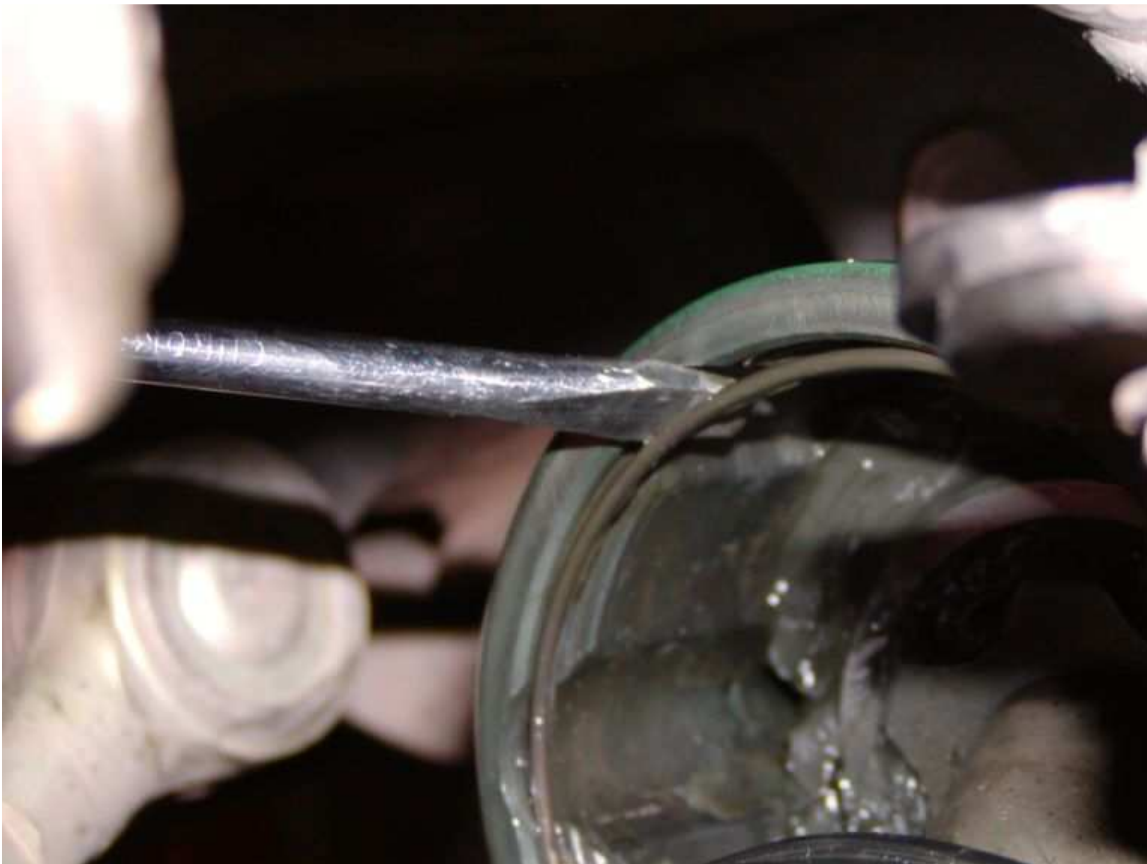
Clean as much grease out as you can. Rags and brake cleaner work great.
Next locate the wire ring just inside the inner lip and slide a screw driver under it. Pop the ring out. This is the retainer ring that holds your CV joint and axle shaft in!

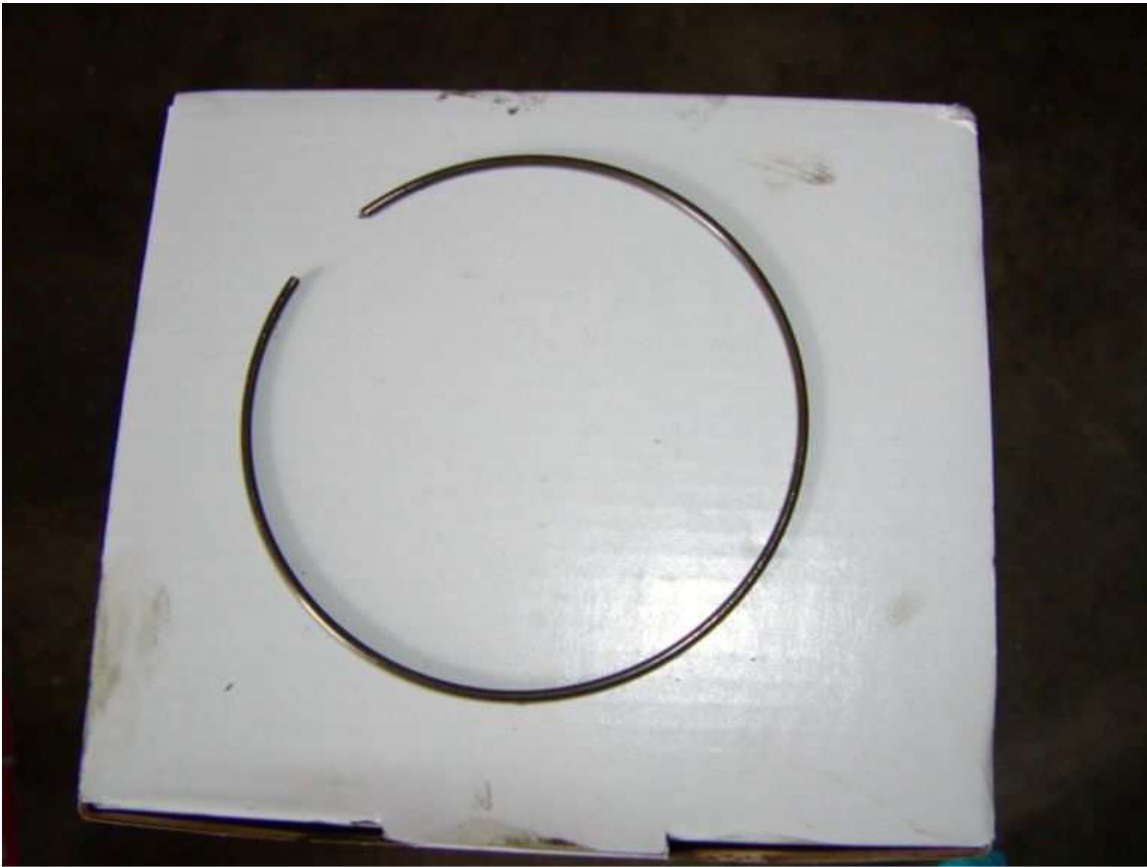
This is the ring once removed.

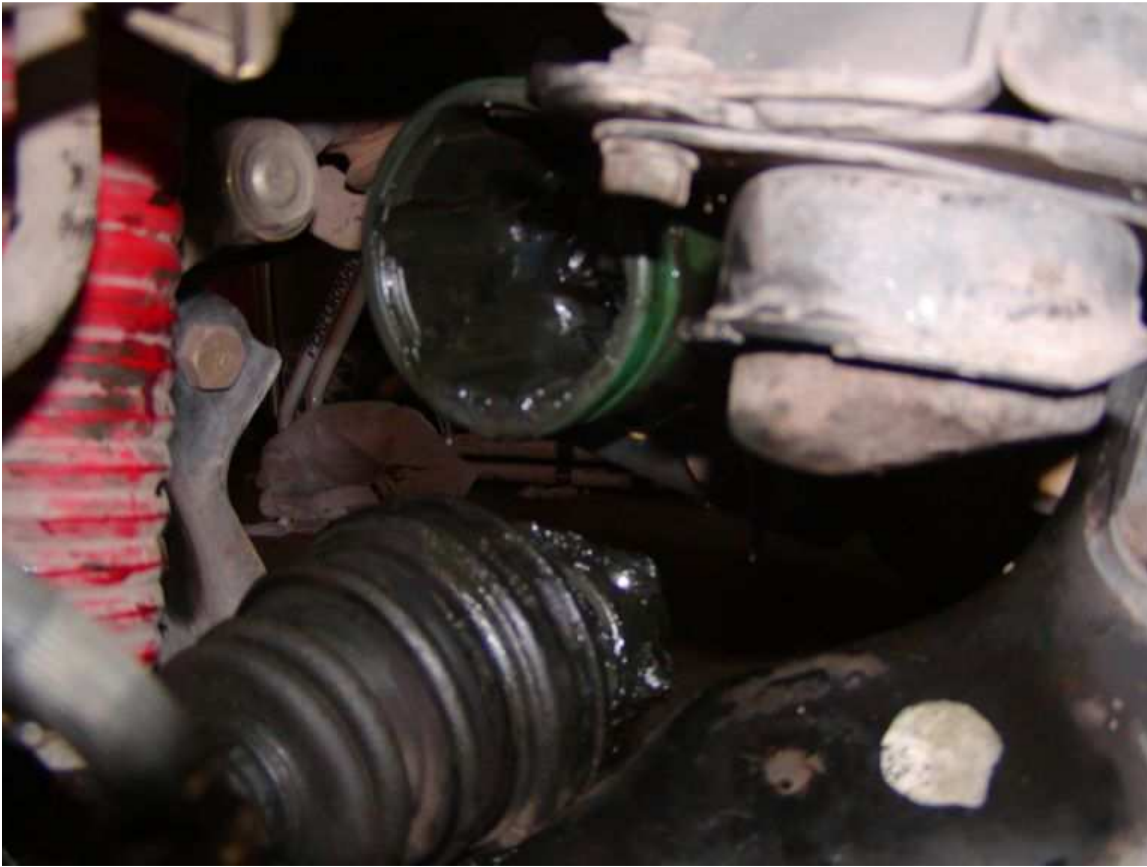
Next you pull the CV joint out by pulling the brake assembly outward. This is the result.

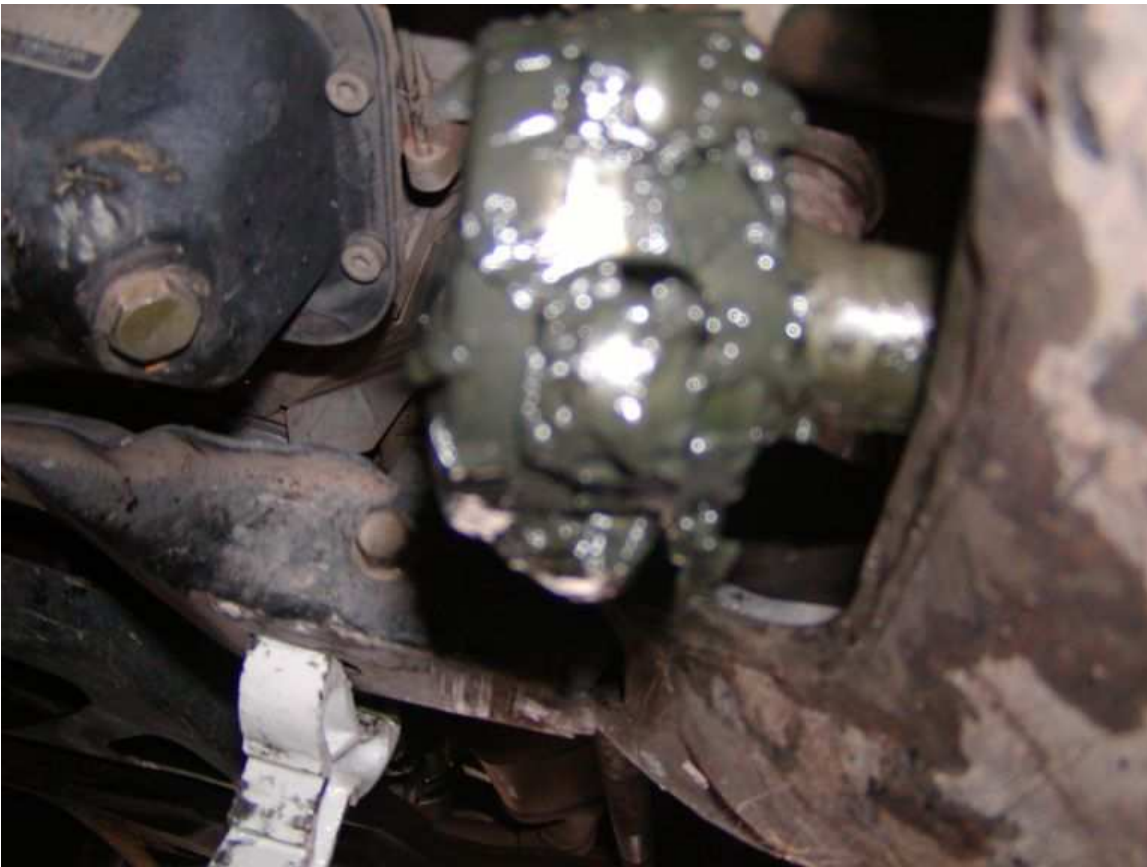
Be prepared for the balls to fall out.
This is what the CV joint will look like...yeah its greasy!

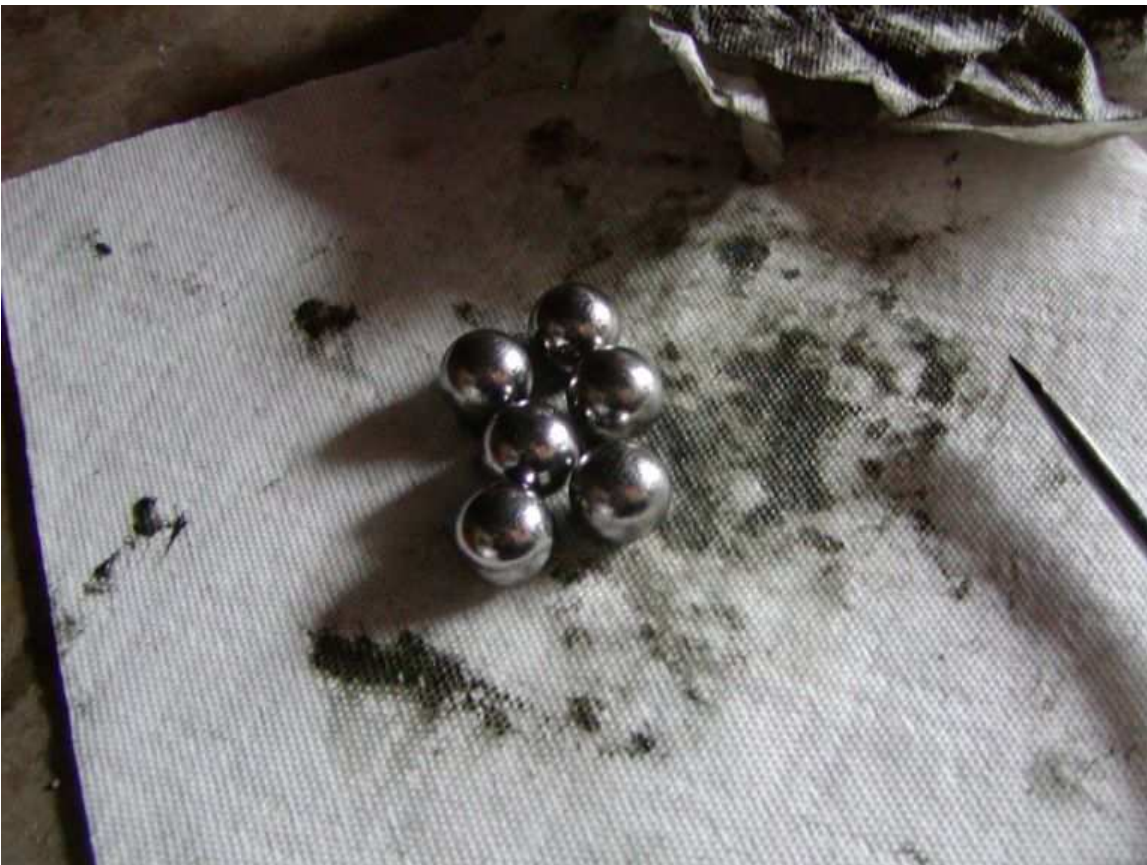
Use the brake cleaner and rags to clean it up.
Use a screw driver to remove the 6 balls.

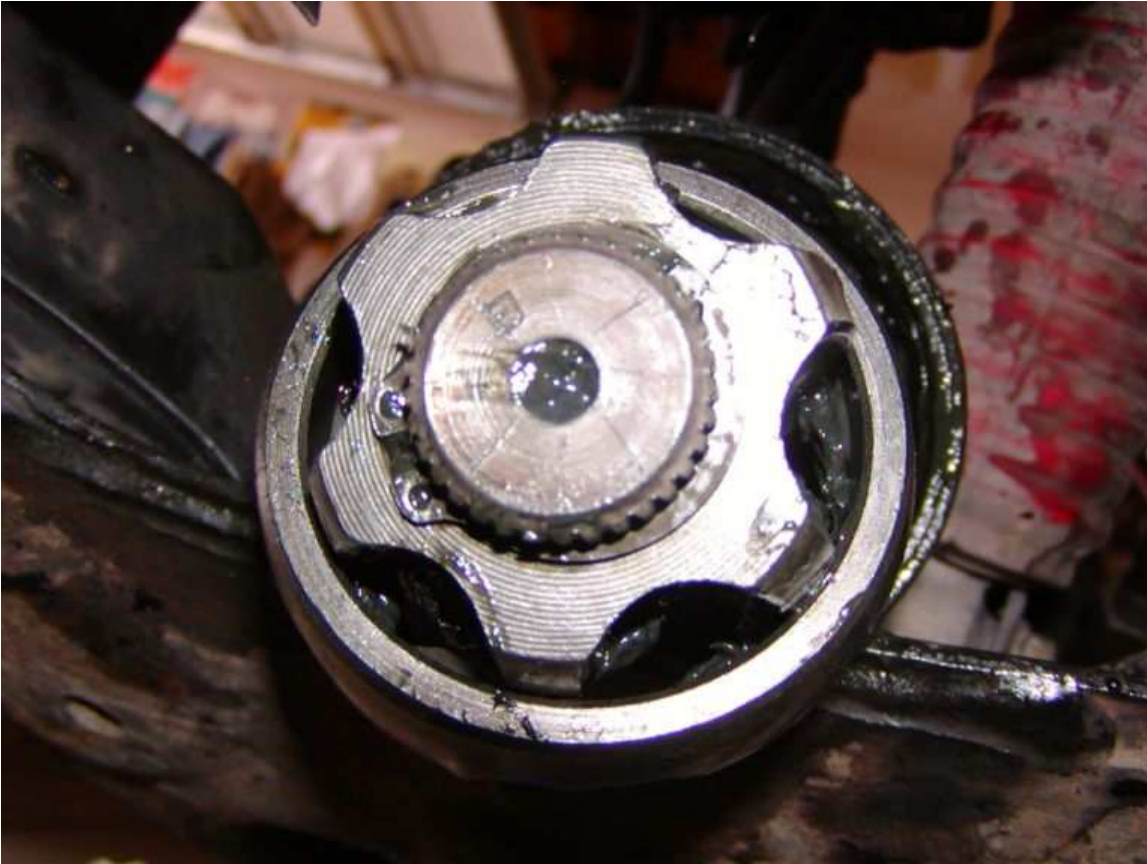
There is a snap ring on the end of the shaft.

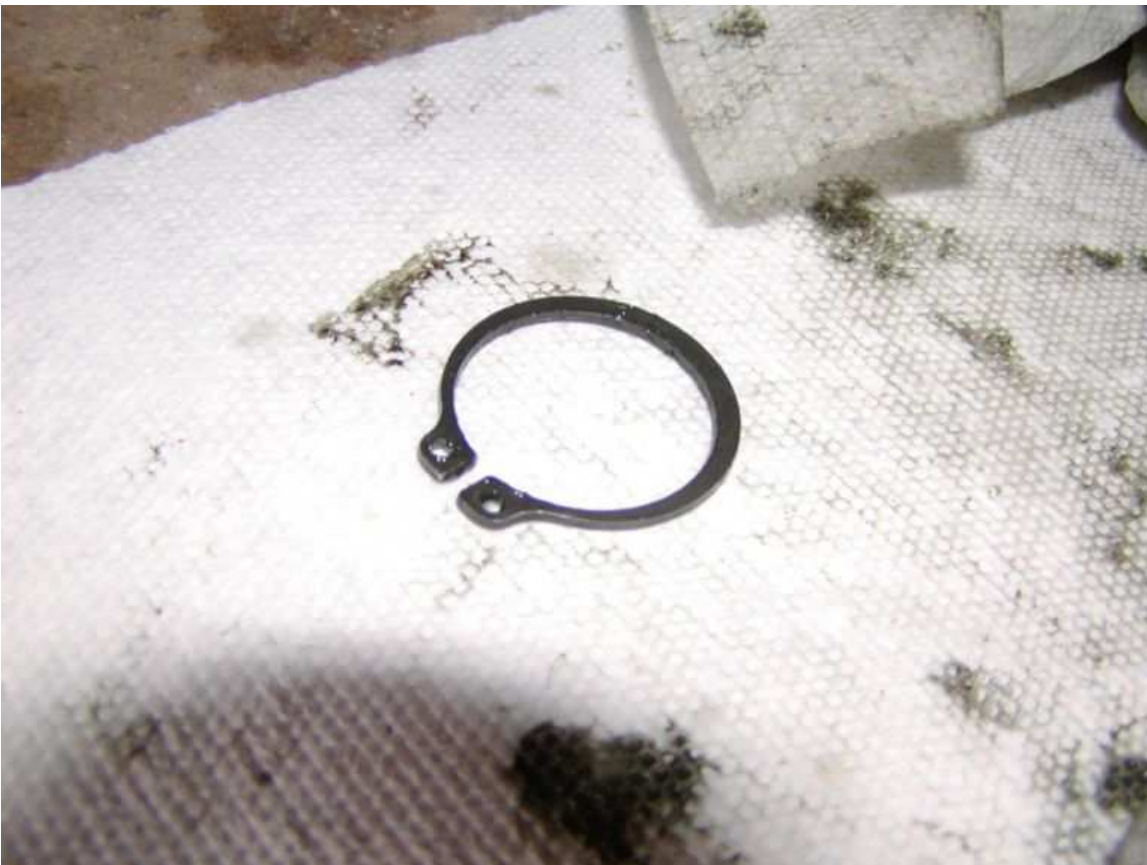
Remove the ring with snap ring pliers.
The snap ring once removed.

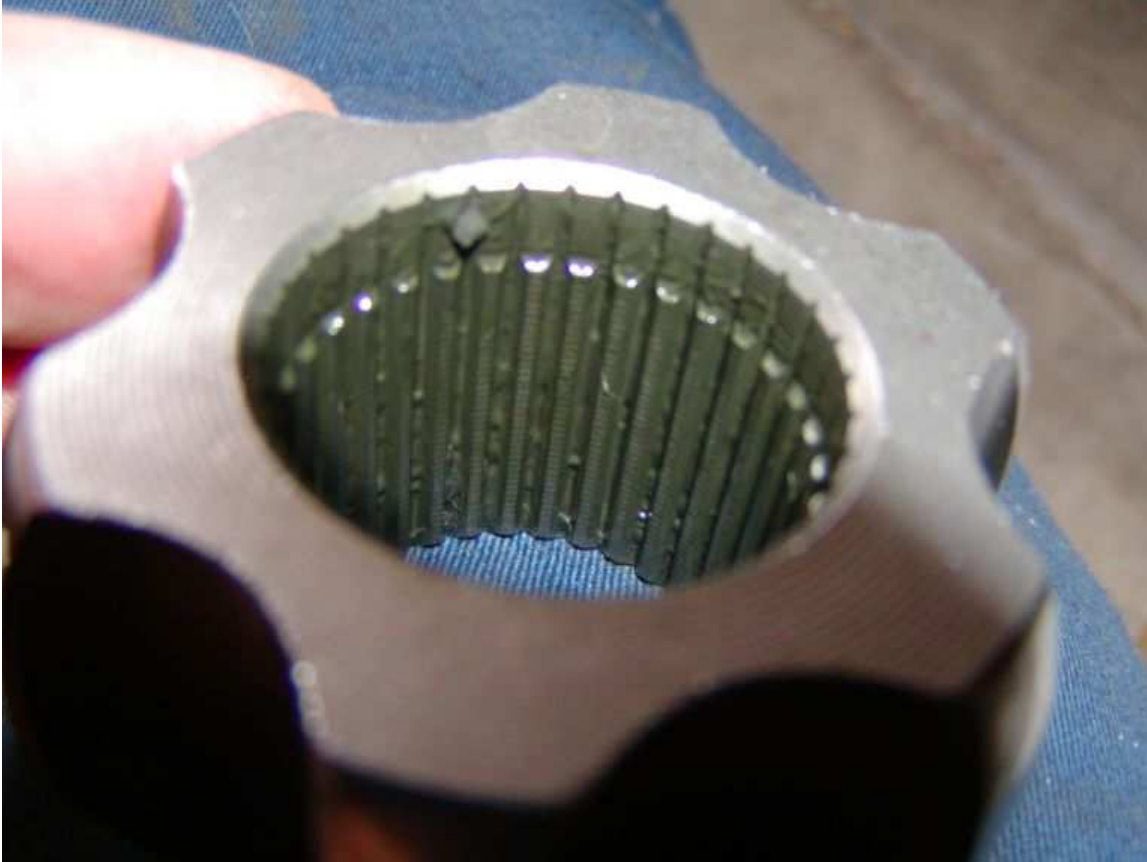
Next remove the inner part of the CV joint from the splined shaft. I needed to use a small gear puller on mine since it was pretty tight. Once removed, notice the recessed inner part on one end. That side goes on first when reinstalling it or it will not fit on all the way. You can see it here...

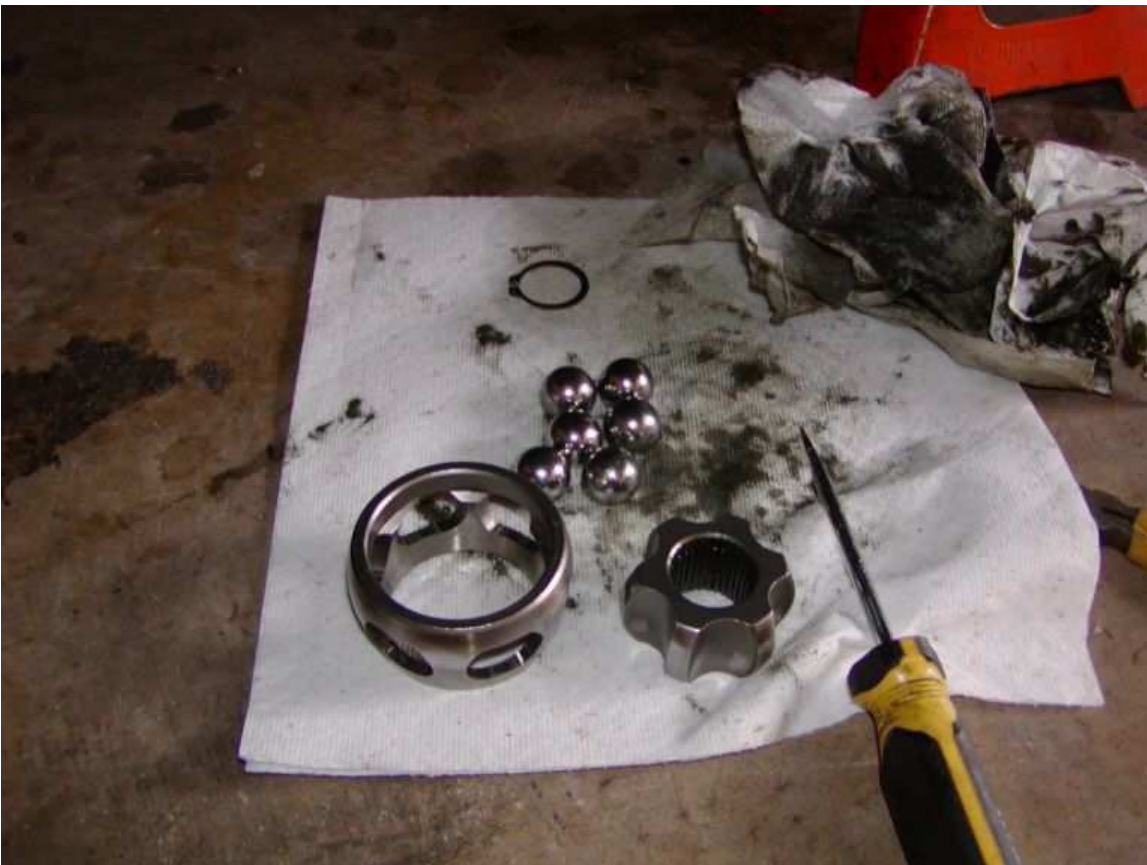
Now the outer crown will also come off. Notice which way it comes off for reinstalling later. Here are all the CV joint parts removed...

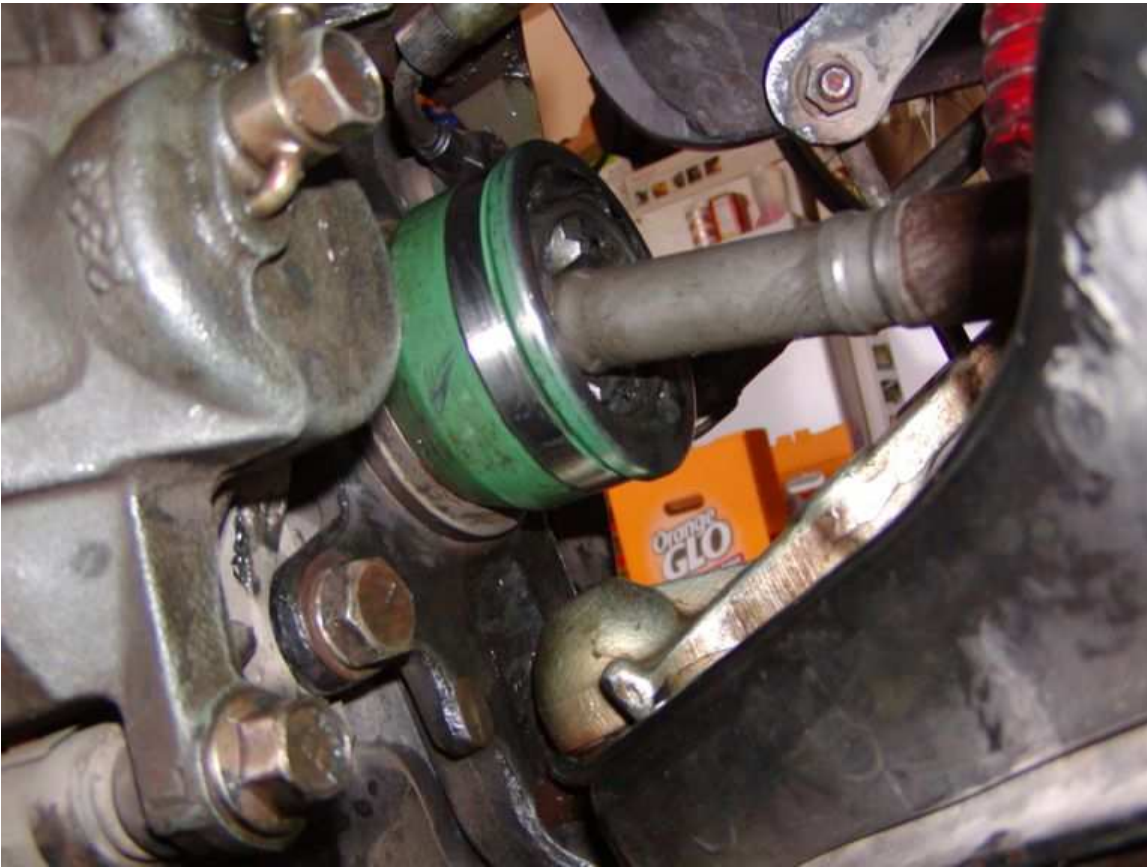
Clean the outer CV joint using the brake cleaner and rags. You can also use high pressure air to blow out the CV joint. The thing is you need to get out any dirt that may have gotten into the CV joint through the tear in the boot.

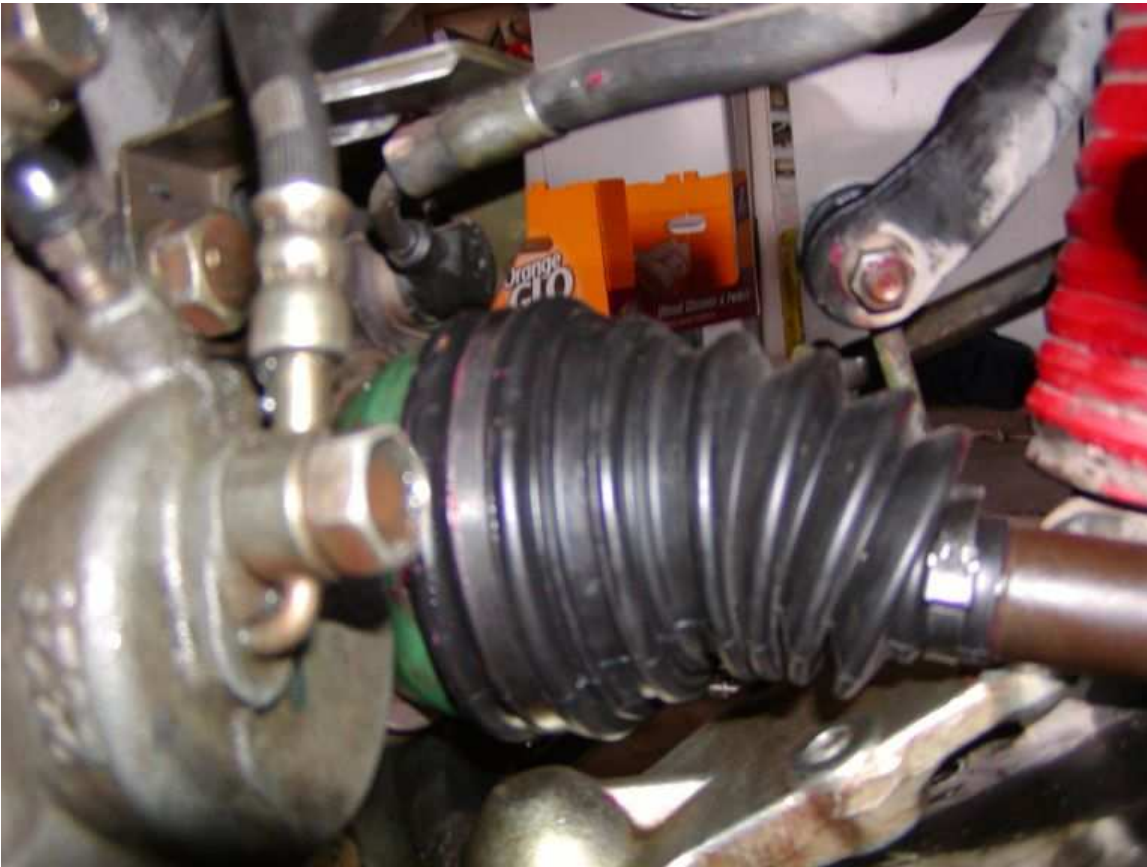
Slide the outer (large end) on and apply the strap. The strap tool really would have helped here but I managed by using a screw driver, pliers and cutters. You then "burp" any extra air out of the boot by sliding a screw driver under the small end and squeezing the boot. Remove the screw driver and allow the boot to go back into shape. Apply the small end strap. The straps line up on the grooves on the large end and on the groove on the shaft on the small end.

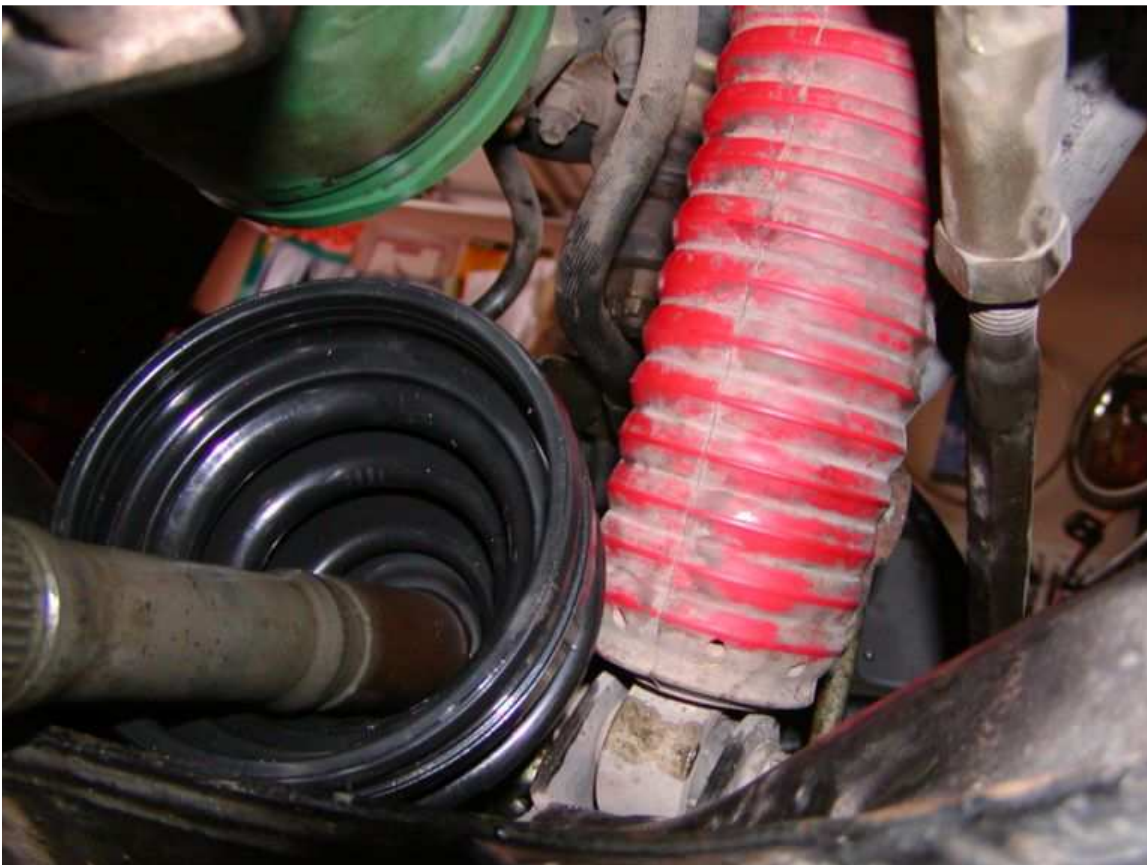
Next slide the new inner boot on (small end first).

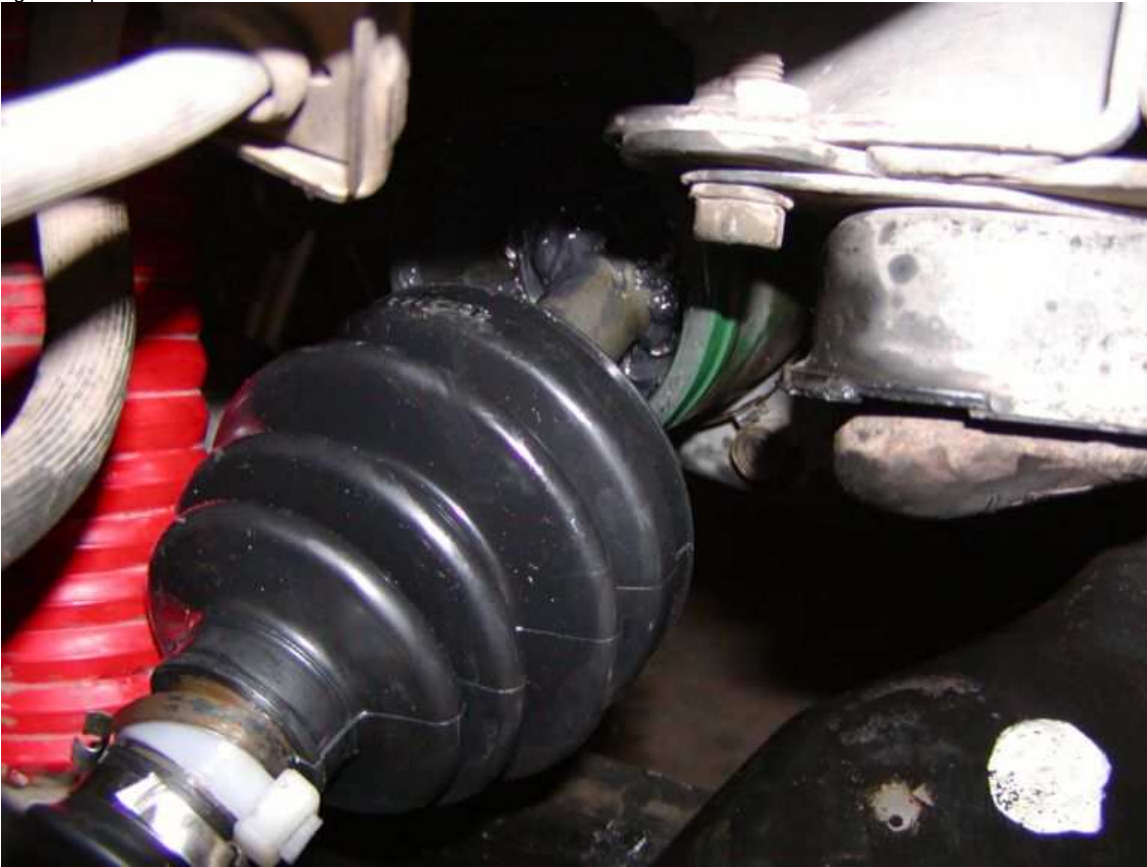
Now carefully manipulate it back into the space it came out of. You will have to move the assembly around until it all lines up and then it will just drop right into place.

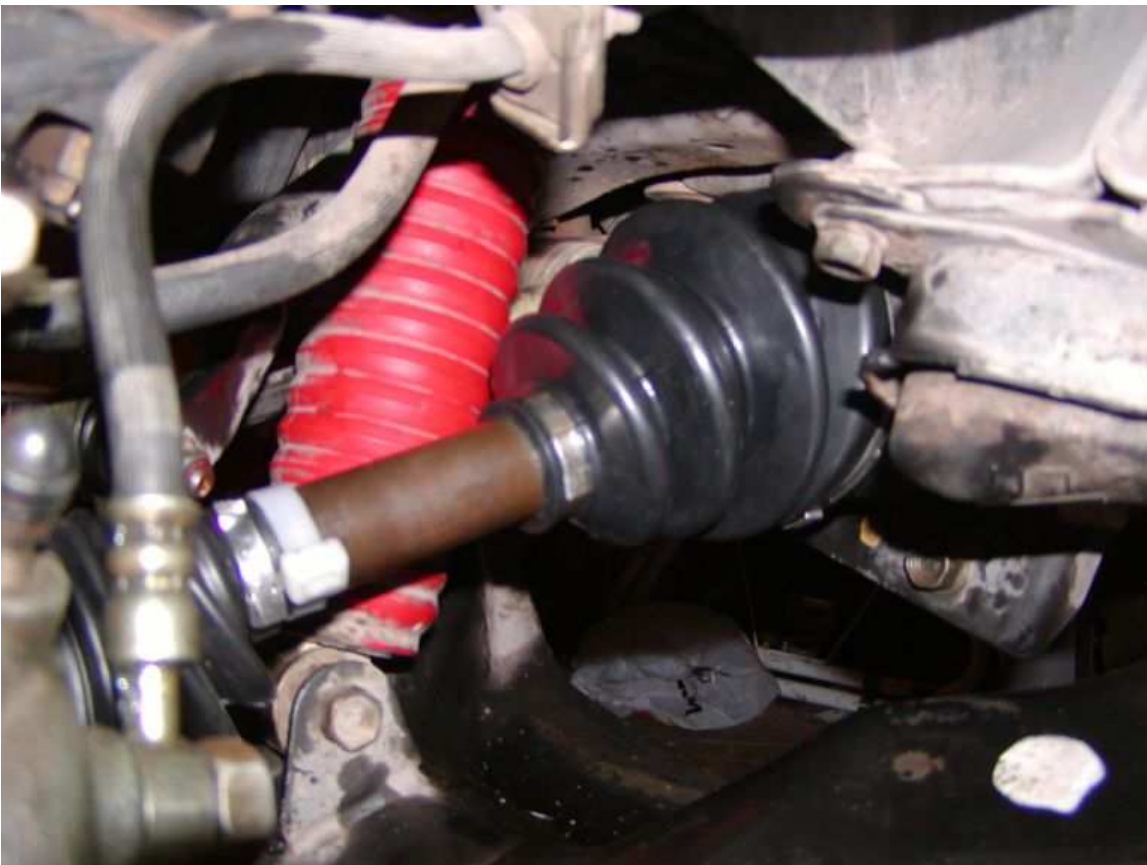
Now slide the large end of the boot into place and secure it with the supplied strap. Burp the air and slide the small end into place on the shaft. Apply the small strap.
